ISSUE 2 2006

Flight Comment

- ✦ *NOTAMs: Do You Really Have Them All? (Part 2)*
- ✦ *Thumbs Up: A Lesson in Hoist Safety*
- ✦ *Helicopter Ground Resonance*

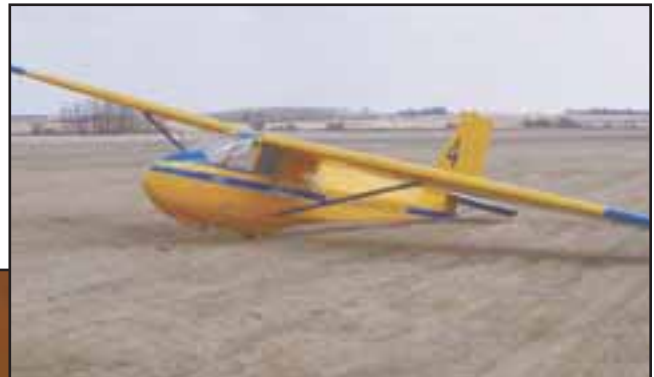
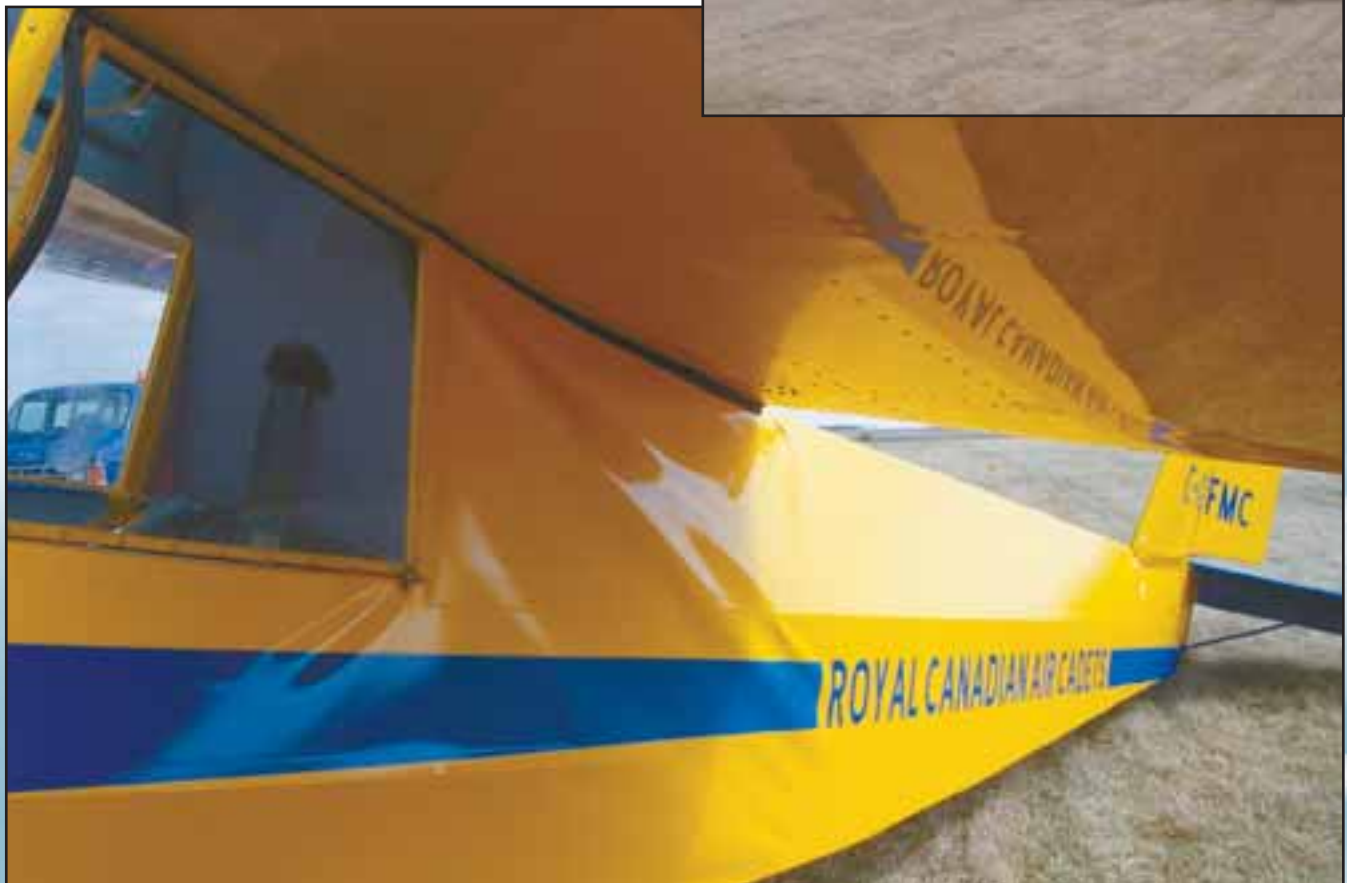
The mission was a winch launch and circuit for two qualified glider pilots. Immediately after becoming airborne, at approximately fifteen feet above ground level, the aircrew felt a loss of power from the winch. The pilot manually released the tow cable and lowered the nose of the glider in an attempt to land straight ahead. As the glider over-flew the tow-rope, the winch motor accelerated and the recovery parachute blossomed. The parachute became entangled with the tail wheel of the glider and as the winch surged it pulled on the tail-wheel which caused the glider to complete a low-level, 360-degree rotation about its lateral axis. The glider impacted the ground in a flat attitude with very little forward speed. The entire sequence, from beginning of the winch launch until ground impact, lasted between 10-15 seconds. Both glider occupants were treated and released from a local hospital with only minor injuries.

Investigation revealed that the winch had not been operating at optimum performance throughout the day. The spark plugs had become increasingly fouled due to a leaking power valve. The normal maintenance inspections did not pick-up this progressive breakdown. Discussion is on-going with respect to treating winch engines as 'airworthiness' assets.

The investigation also noted that after the momentary power loss the winch operator focussed his attention from the glider to the winch, then back to the glider. This delay in reducing the winch engine to idle and applying the cable brake was a contributing factor to this accident. A National Pilot Information File was issued which states, "At any time that a winch experiences a momentary power loss, the immediate action shall be to close the winch throttle and apply the cable brake." Recommendations also address winch operator training. ♦

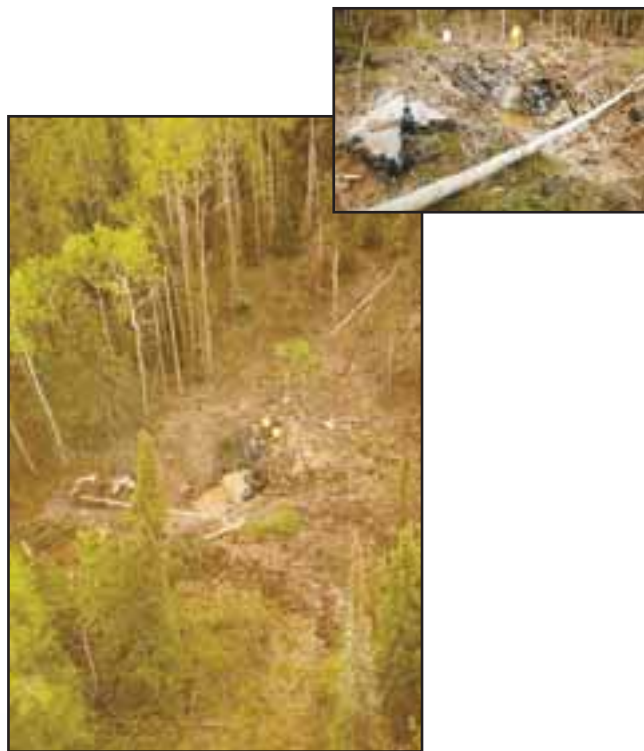
TYPE: *CF188732 Hornet*
LOCATION: *Cold Lake Air Weapons Range, Alberta*
DATE: *26 May 2003*

The CF-188 is not equipped with a flight data recorder (FDR) or a cockpit voice recorder (CVR). However, the aircraft was equipped with an Air Combat Manoeuvring Instrumentation (ACMI) pod, which recorded the aircraft’s flight path all the way to impact. The data recovered from the ACMI, although containing a limited number of parameters, was used extensively to corroborate the investigators’ research and analysis.

The pilot was fatally injured during the ejection sequence. A number of deficiencies were revealed with the CF-188 escape system, both in terms of system limitations, as well as training and procedures used by operators. The escape system is now undergoing a modernization program.

The preventive measures and recommendations for this accident include pilot checklist and training amendments, acquiring an FDR/CVR system, further recommendations for the escape system modernization, and Aircrew Life Support Equipment upgrades. ♦

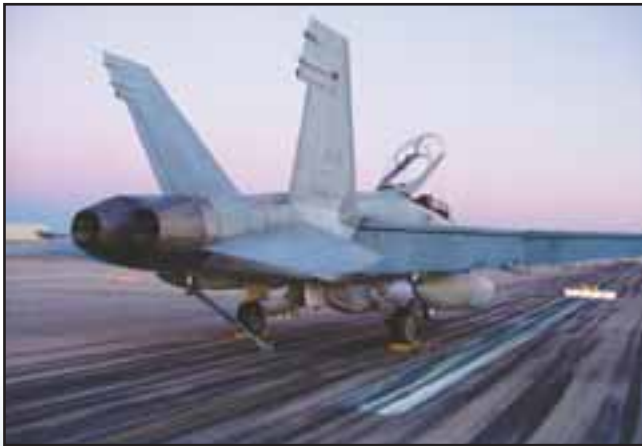
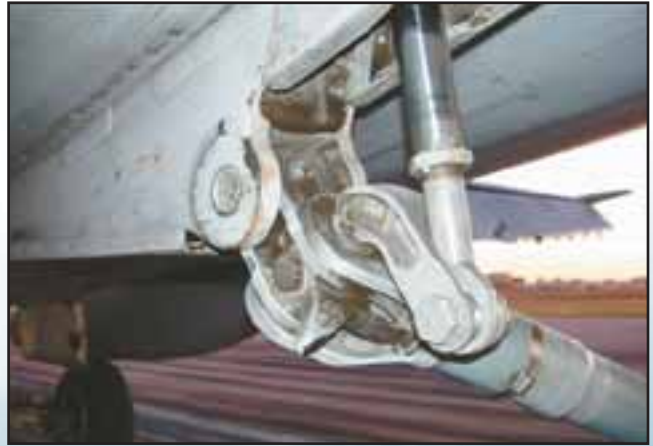
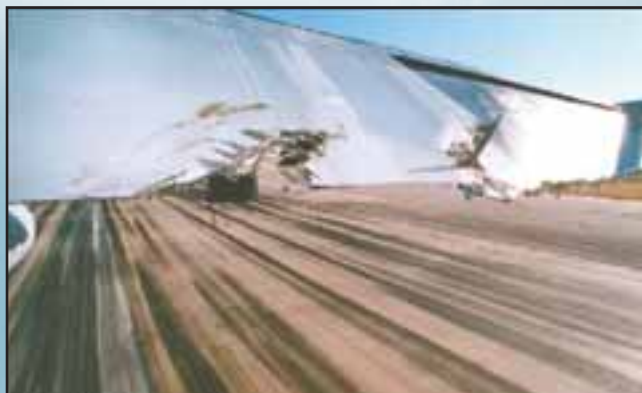
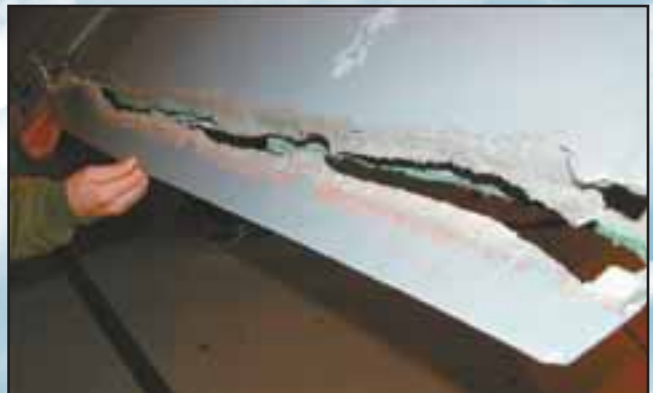
TYPE: CF188933 *Hornet*
LOCATION: Tinker AFB,
Oklahoma, USA
DATE: 13 January 2005

the E-5 arrestor gear in the undershoot area of runway 12, 70' before the threshold. The aircraft's main landing gear then touched down prior to the runway threshold. After encountering difficulty with directional control, the PIC used emergency braking to bring the aircraft to a halt on runway 12, 7500' from the threshold. After conducting a normal shutdown, both pilots egressed uninjured. The aircraft sustained "D" category damage; the E-5 arrestor cable and runway also sustained damage.

The Flight Safety Investigation revealed that the CF-188 crew were unaware that the tail-hook touchdown point can be over 500 feet prior to the intended aim-point (depending on variables such as glide path angle, and angle of attack). Recommendations include amending manuals to ensure aircrew are aware of the difference in touchdown points.

The engine oil pressure fluctuations were caused by a faulty connector which had failed due to a cracked oil pressure transmitter bracket. False oil pressure indications have resulted in approximately 15 single-engine landings over the past five years. Recommendations include a re-design of the transmitter bracket, and modifications to the inspection procedures. ♦

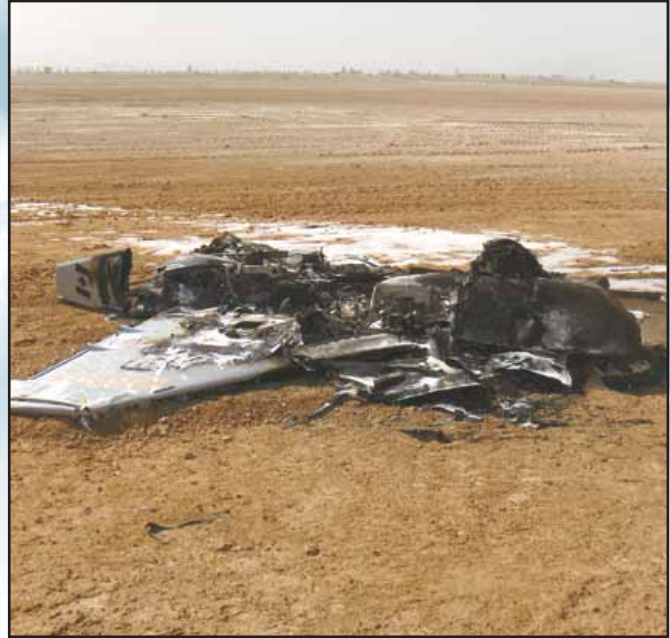
TYPE: CU161009 *Sperwer*
LOCATION: Kandahar, Afghanistan
DATE: 06 May 2006

The accident occurred during a day mission conducted in the vicinity of Kandahar Airfield in support of Op ARCHER. During the recovery phase of flight, the parachute failed to deploy. The air vehicle (AV) descended freely, impacted the ground at high speed and exploded. The AV was consumed by post-impact fire and sustained 'A' category damage. There were no injuries.

The flight was without incident up to the recovery phase at which point the parachute failed to deploy. The investigation will focus on areas associated with parachute system design and parachute rigging. ♦

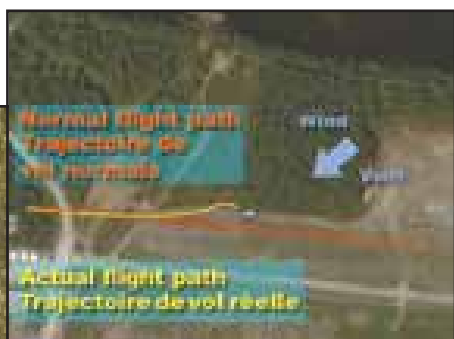
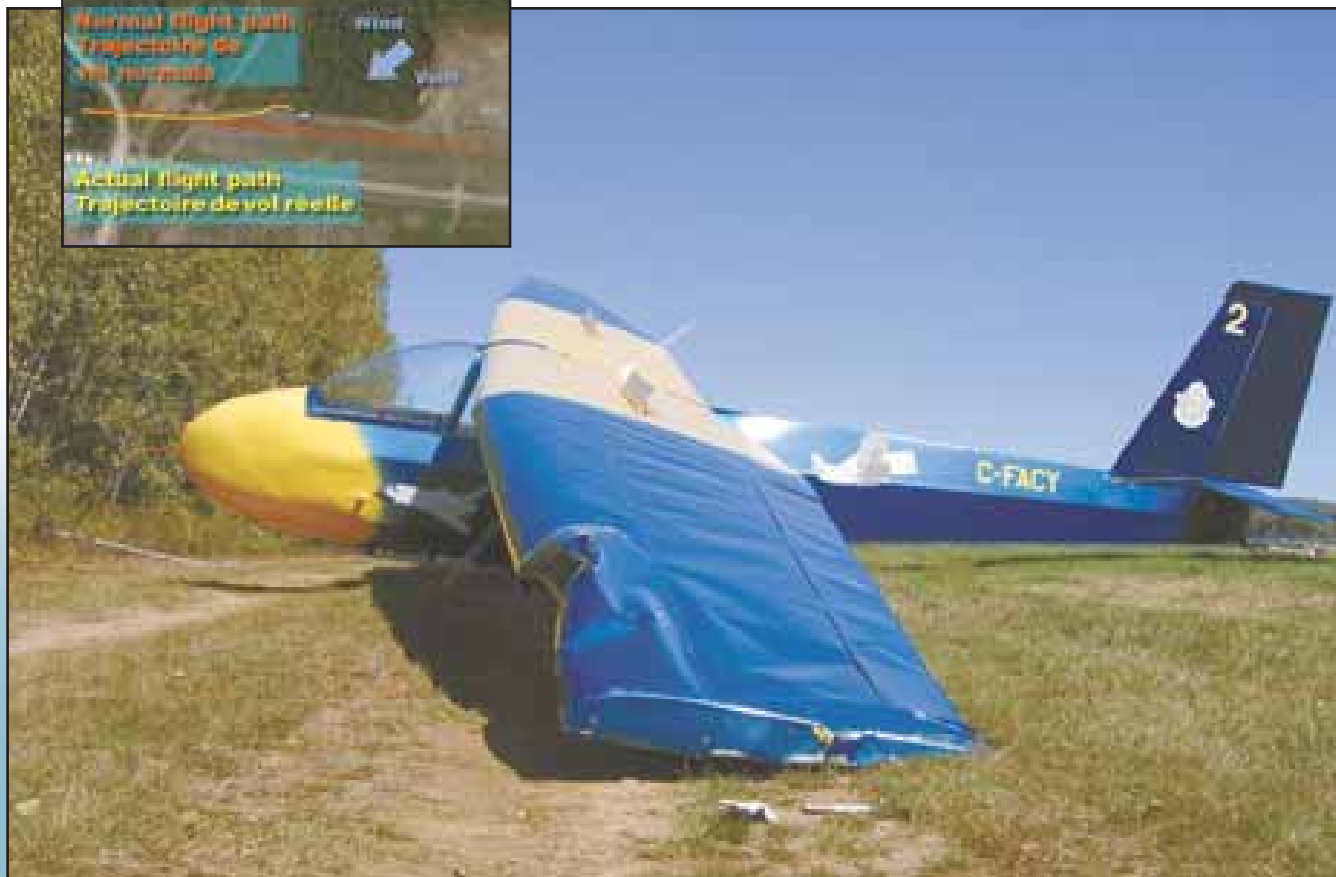
TYPE: SZ2-33A *Schweizer C-FACY*
LOCATION: Valcartier, Quebec
DATE: 10 September 2006

the centre-line of the runway. The left crosswind abruptly ceased as the glider descended below the height of the trees that line the left side of the runway. This caused the glider to drift left towards the forested area and lose airspeed. The glider also encountered some downdrafts. The pilot attempted to correct back to the runway centre-line, however, the glider's left wing contacted some trees at 23 feet above ground level. The glider pivoted 90 degrees to the left and fell almost vertically. The pilot suffered serious injuries. The glider sustained 'B' category damage.

The investigation is focussing on the proximity of the trees to the landing area and the localized wind shear phenomenon that is well known by Valcartier pilots. The proximity of the trees to the landing area allows for only 18 feet of clearance between the glider's wingtip and the trees when landing on lane 1. The condition which is conducive to the development of wind shear is a left crosswind on runway 04, or a right crosswind on runway 22.

Immediate preventive measures include moving the main landing area to lane 2 which is further from the tree line. All pilots will be briefed on the local wind shear phenomenon, and this information will be included in the Regional Flying Orders. ♦

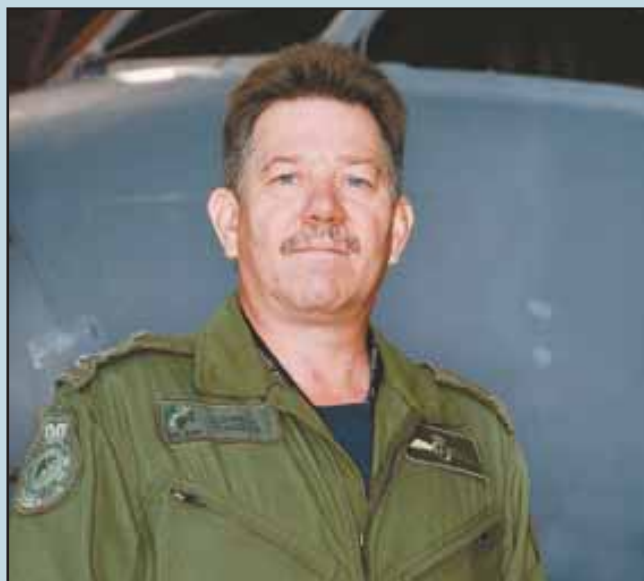
In October 2005, Sergeant O'Keefe, a flight engineer (FE) on the CP-140 *Aurora*, was conducting an external pre-flight inspection when he noticed a crack on the nose wheel steering cylinder nut. The nose gear area had accumulated dust and dirt over time, masking this particular crack. Many technicians and FEs who had worked in and inspected this area had missed this defect. Although the FE external pre-flight inspection of the nose wheel area includes several steps, there is no mention to inspect the nose wheel cylinder.

Closer inspection revealed that the crack was 8 inches long. The nose wheel cylinder nut, normally installed with 800-1000 inch lbs of torque, required very minimal force to be removed indicating failure was likely imminent.

Following testing at the Quality Engineering Test Establishment, it was determined that the fault in the nut was a progressive fatigue crack that had been present for quite some time. In light of this incident, nose wheel steering cylinder nuts are now inspected for fatigue cracks at 3rd line overhaul.
